**Flood Control Project Maintenance
Levee Inspections**
LMA District Cover Sheet
Spring 2017 Levee Inspection Results

Reclamation District No. 0785 Driver

Spring 2017 Levee Inspection Results

Waterway			Bank	Unit Miles
Unit No. 01 Sacramento River			Right	2.26
	Spring (March - May)	Summer (June - August)	(September - November) Fall	Winter (December - February)
Unit Maintenance Rating (Fall Only)				
Date of Inspection	4/13/2017 - 4/13/2017			
DWR Inspector	Zach Jojola			
Accompanied By	Oleg Yakimov DWR

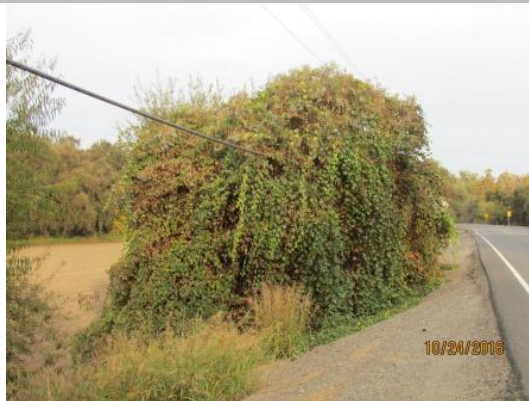
Photo 1 of 1 : SP_2017_RD0785_185_1_20170320_00001.jpg

LM Start	0.28	Rating **	A/W	Issue No.	1
LM End	0.28	Issue Type +	Ma	Location *	LS
Category	Earthen Levee			GPS Latitude/Longitude	
				Start	End
Item	Vegetation			38.658467 °	38.658467 °
				-121.609573 °	-121.609573 °
DWR ID	DWR_RD0785_01_s_2012_1				
Comment Code					
V4 : Elderberries are blocking visibility and flood fight capability.					
Inspector Comment

Elderberry tree on LS slope. Fall 2016.

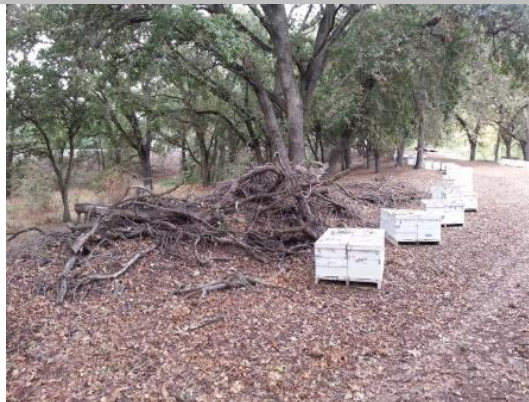
Photo 1 of 2 : SP_2017_RD0785_185_14_20170320_00011.jpg

LM Start	0.67	Rating **	M	Issue No.	14
LM End	0.67	Issue Type +	En	Location *	LS
Category	Earthen Levee			GPS Latitude/Longitude	
				Start	End
Item	Encroachments			38.654207 °	38.654207 °
				-121.605141 °	-121.605141 °
DWR ID	DWR_RD0785_01_f_2015_14				
Comment Code					
PR : Prunings					
Inspector Comment

Updated view of pruning pile. Fall 2016.

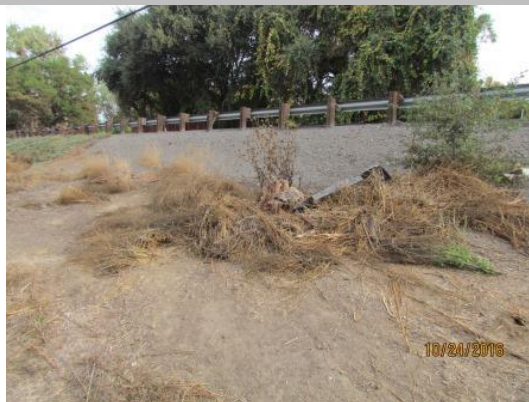
Photo 1 of 1 : SP_2017_RD0785_185_31_20170320_00026.jpg

LM Start	1.11	Rating **	U	Issue No.	31
LM End	1.11	Issue Type +	Ma	Location *	LS
Category	Earthen Levee			GPS Latitude/Longitude	
				Start	End
Item	Trim / Thin Trees			38.648813 °	38.648813 °
				-121.601380 °	-121.601380 °
DWR ID	DWR_RD0785_01_f_2016_31				
Comment Code					
T5 : Tree stumps.					
Inspector Comment					
Decomposing tree stump

Decomposing tree stump near levee toe on landside. Fall 2016.

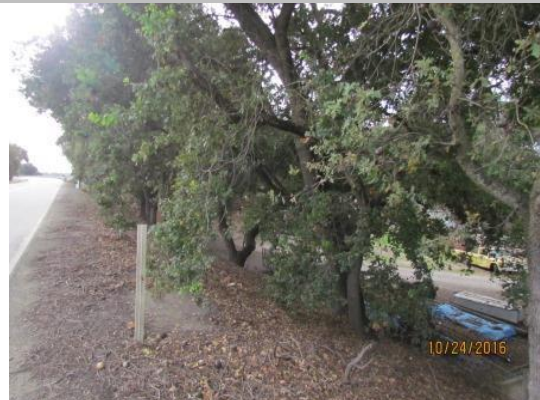
Photo 1 of 1 : SP_2017_RD0785_185_22_20170320_00017.jpg

LM Start	1.61	Rating **	M	Issue No.	22
LM End	1.62	Issue Type +	Ma	Location *	LS
Category	Earthen Levee			GPS Latitude/Longitude	
				Start	End
Item	Trim / Thin Trees			38.643359 °	38.643229 °
				-121.595237 °	-121.595011 °
DWR ID	DWR_RD0785_01_s_2016_22				
Comment Code					
T1 : Trim trees to at least five feet above ground level.					
Inspector Comment

Fall 2016.

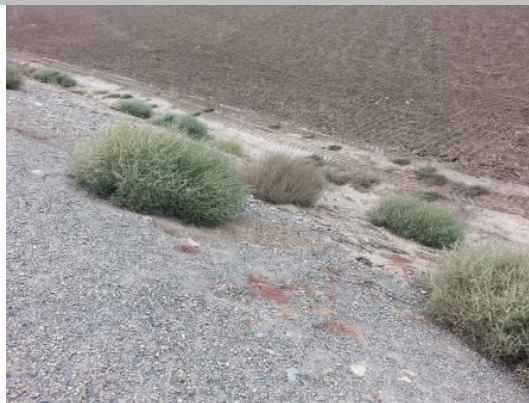
Photo 1 of 1 : SP_2017_RD0785_185_38_20170320_00033.jpg

LM Start	1.79	Rating **	M	Issue No.	38
LM End	1.79	Issue Type +	Ma	Location *	LS
Category	Earthen Levee			GPS Latitude/Longitude	
				Start	End
Item	Animal Control			38.641910 °	38.641910 °
				-121.592389 °	-121.592389 °
DWR ID	DWR_RD0785_01_f_2016_38				
Comment Code					
A3 : No rodents visible, but rodent burrows visible; need to backfill and compact or grout burrows.					
Inspector Comment

Rodent holes on LS slope. Fall 2016.

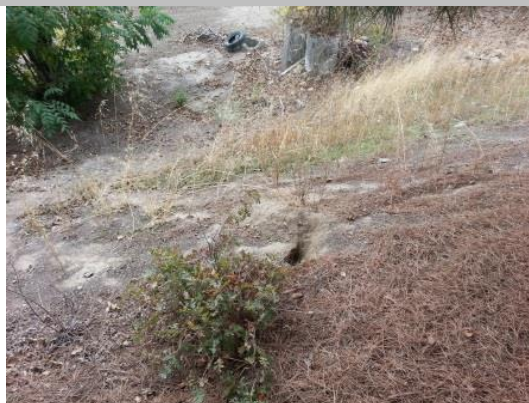
Photo 1 of 1 : SP_2017_RD0785_185_40_20170320_00035.jpg

LM Start	2.01	Rating **	M	Issue No.	40
LM End	2.01	Issue Type +	Ma	Location *	LS
Category	Earthen Levee			GPS Latitude/Longitude	
				Start	End
Item	Animal Control			38.641610 °	38.641610 °
				-121.588428 °	-121.588428 °
DWR ID	DWR_RD0785_01_f_2016_40				
Comment Code					
A3 : No rodents visible, but rodent burrows visible; need to backfill and compact or grout burrows.					
Inspector Comment

Rodent burrows on LS slope of the levee. Fall 2016.

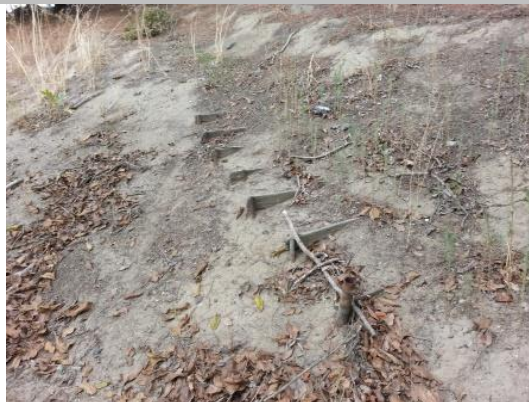
Photo 1 of 1 : SP_2017_RD0785_185_41_20170320_00036.jpg

LM Start	2.02	Rating **	M	Issue No.	41
LM End	2.02	Issue Type +	En	Location *	LS
Category	Earthen Levee			GPS Latitude/Longitude	
				Start	End
Item	Encroachments			38.641687 °	38.641687 °
				-121.588287 °	-121.588287 °
DWR ID	DWR_RD0785_01_f_2016_41				
Comment Code					
ST : Stairway					
Inspector Comment					
old wooden steps

View of old abandoned stairway on LS slope. Fall 2016.

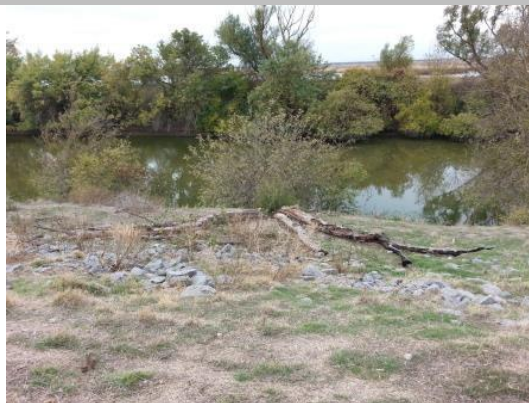
Photo 1 of 3 : SP_2017_RD0785_186_56_20170320_00028.jpg

LM Start	3.01	Rating **	M	Issue No.	56 (cont)
LM End	3.01	Issue Type +	Ma	Location *	WS

Updated view of a tree on waterward side of the levee. Fall 2016.

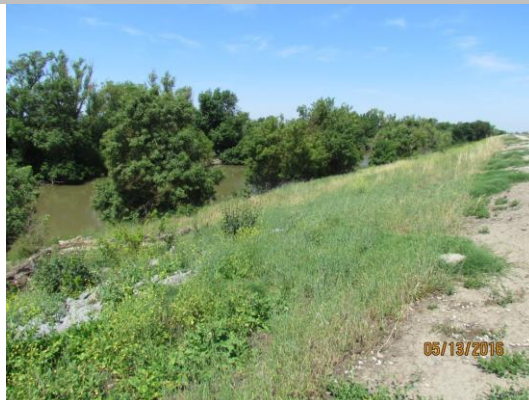
Photo 3 of 3 : SP_2017_RD0785_186_56_20170320_00030.jpg

LM Start	3.01	Rating **	M	Issue No.	56 (cont)
LM End	3.01	Issue Type +	Ma	Location *	WS

Perspective view of the tree looking upstream. Spring 2016.
